NABARLEK MINERAL LEASE

MINING MANAGEMENT PLAN MLN 962

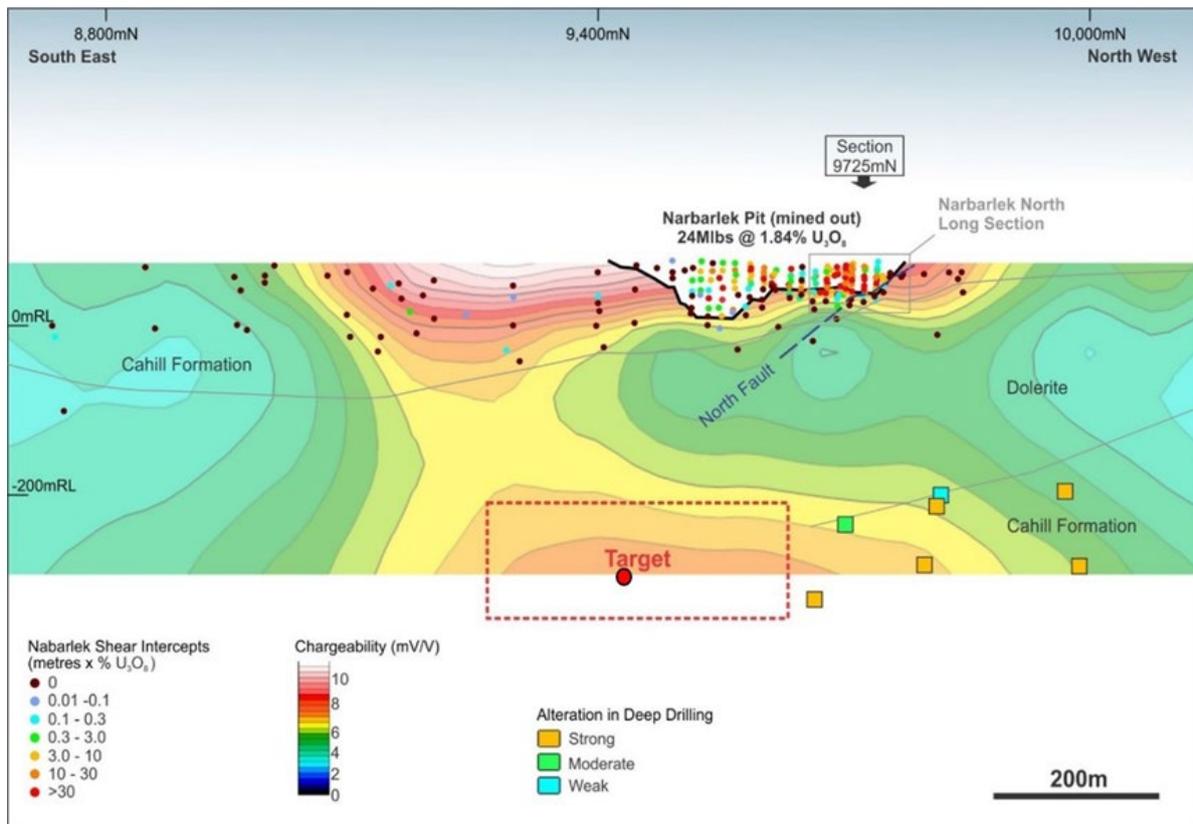
Figure 4: Nabarlek long-section (with 3DIP slice at 10120mE) showing piece-point location of proposed drill hole (red dot) beneath the pit in relation to the IP chargeability anomaly which is the drill target for this programme. Note position of alteration in previous deep holes 250m to the north missed the IP anomaly but showed encouraging fault breccias and silica sericite alteration

During the 2018-19 field season a 3-dimensional IP survey was completed over the Nabarlek Uranium Mine to map extensions to alteration and sulphides associated with uranium mineralisation, resulting in the definition of a chargeability anomaly located beneath the historical open pit. The anomaly is located beneath the Oenpelli Dolerite and is interpreted to be a deflected extension of the North Fault, which was a controlling feature of the Nabarlek deposit and the position where

highest grades were recorded. The extension of this crucial feature has not yet been located beneath the Oenpelli Dolerite with drilling largely having targeted to the north.

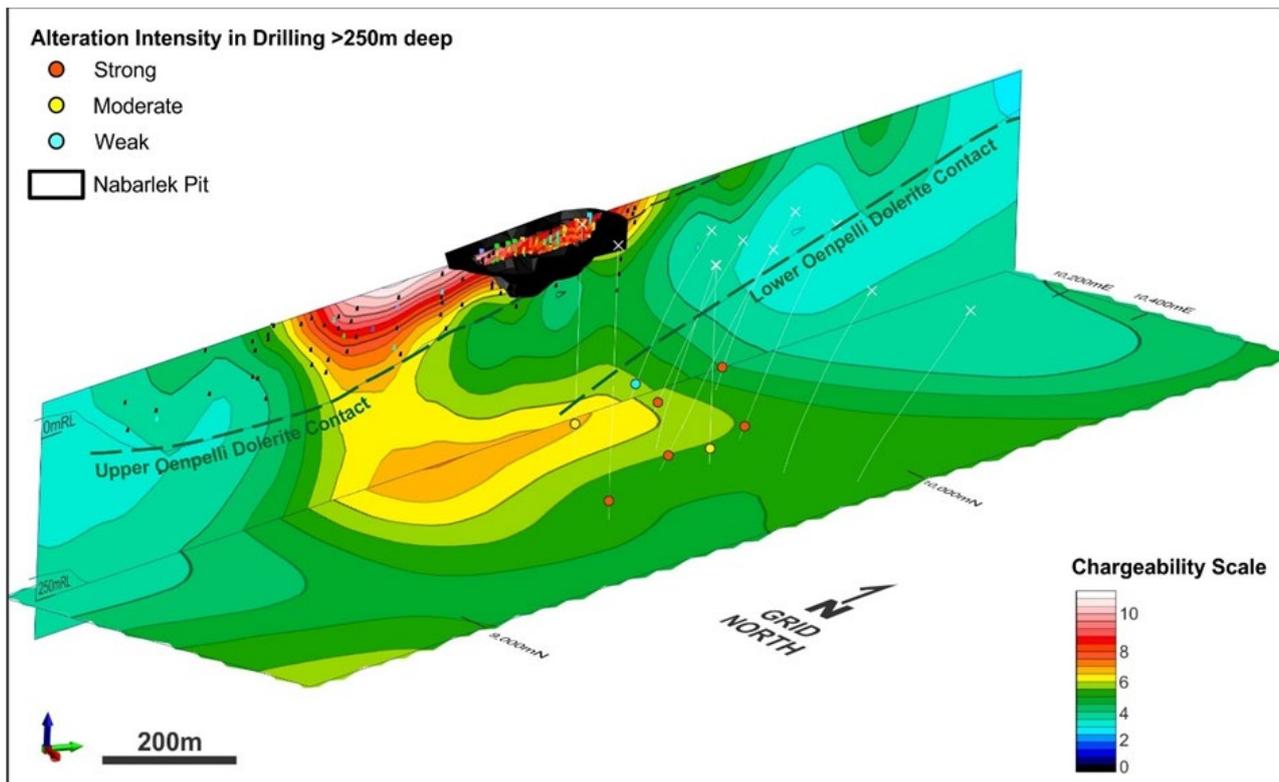
Figure 5: 3rd Dimension representation of IP Anomaly beneath Nabarlek pit in context to historical drilling. Nabarlek long-section showing mined-out pit in relation to the deeper IP chargeability anomaly which is the drill target for this programme. Note of alteration in previous deep holes north of the IP anomaly showed encouraging breccia faulting and silica sericite alteration

The previous deep drilling assumed a linear path from the position of the Nabarlek Shear following a hypothetical northern plunge to the position of the shear beneath the Oenpelli Dolerite. DevEx interprets favourable structural dilation within the Myra Falls Metamorphics (Cahill Formation equivalent) where F6 and Nabarlek Shear “type” structures pass through the upper and lower contacts of the Oenpelli Dolerite. The southern projection of the North Fault provides additional conceptual support that the most favourable structural position for repetition of Nabarlek Uranium mineralisation is immediately north of the intersection of the projected North Fault with the Nabarlek Shear where it lies immediately beneath the Oenpelli Dolerite. The recent 3DIP chargeability anomaly provides further support to this exploration target, as shown in Figure 5.

The Nabarlek deposit was hosted by Cahill Formation schists just above the flat lying, 250m thick, Oenpelli Dolerite sill. The new chargeability anomaly is located in Cahill Formation schists just below the lower contact of the Oenpelli Dolerite sill and is an attractive drill target. The Oenpelli Dolerite predates mineralisation and its upper and lower contacts provide favourable positions for structural complications in through-going mineralised feeder structures such as the Nabarlek Shear and the North Fault (Figure 5).

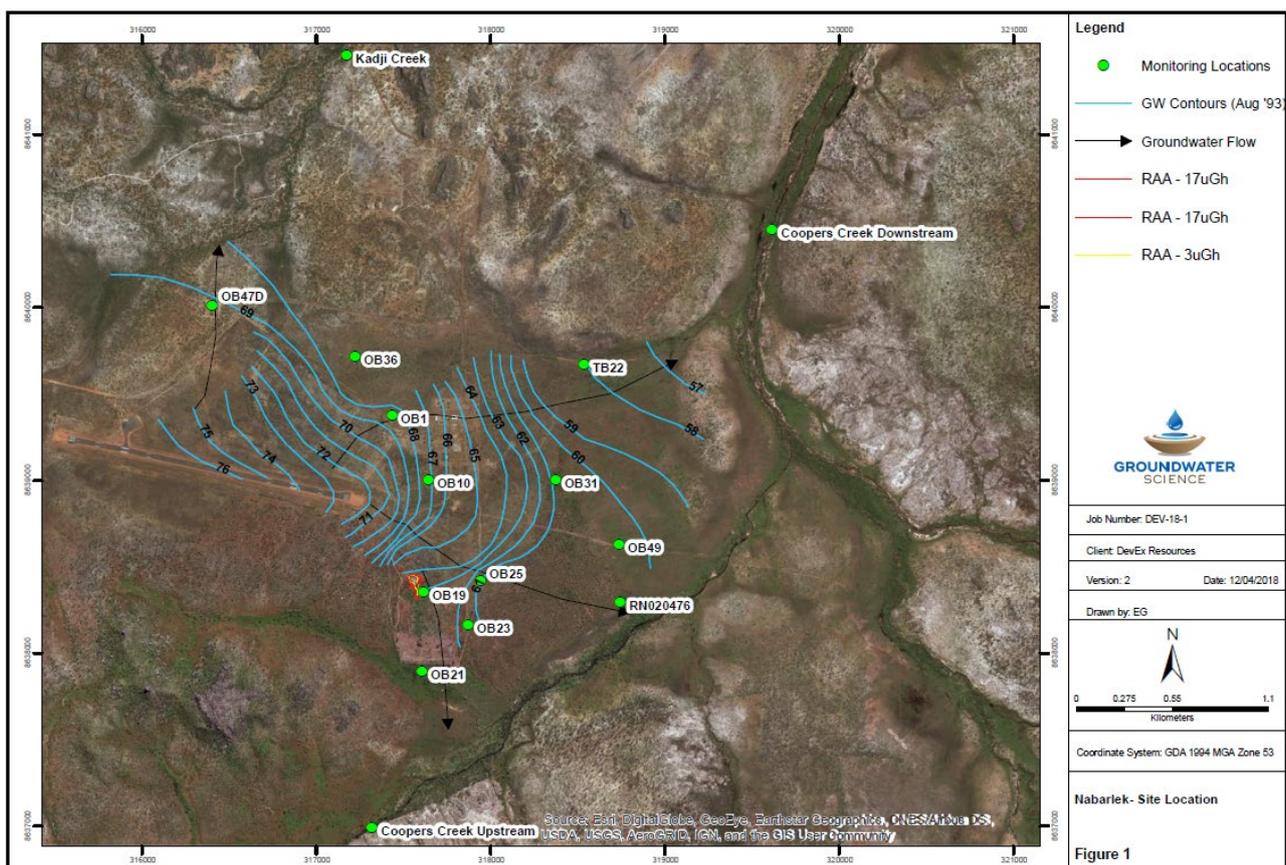
Figure 12: Groundwater flow is inferred to be to the east and south of the RAA and the mine pit, based on the water table elevation measured from an extensive suite of wells in August 1993 (QML 1993).
Review of water and environmental monitoring: 1 Sept. 1992 to 31 Aug 1993)

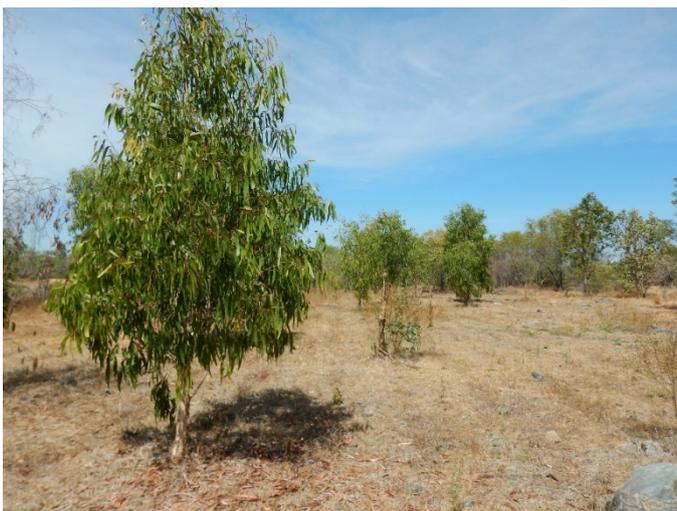
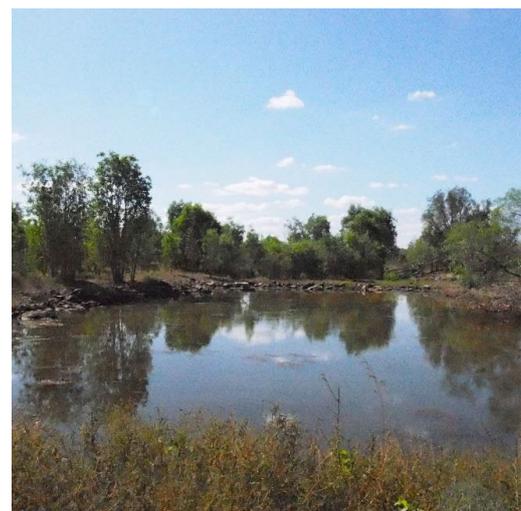
Figure 18: Plant Runoff Pond 2017 (and 2018) Photos

A 2013 Revegetation Programme at the Plant Runoff Pond has shown good survival rates of greater than 90%. The 2017 review of the area has found that vegetation has continued to thrive since 2016 (Figure 19 and Figure 20) and is attributed to the higher availability of water in the area. No further work is planned for this area until recontouring takes place.

In May 2018 the Company visited the Plant Runoff Pond area with a civil earth moving contractor and environmental consultants COOE Pty Ltd to assess and to quote the work required to back fill the pond and recontour the drainage so to avoid damaging the revegetation and avoid future ponding. Drainage north of the current Plant Runoff Pond will be redirected at the northern limit of the pond to the south east (see arrow in Figure 20) to prevent a loss of melaleuca populations. A stockpile of soil from the original digging at the pond is located outside of the perimeter fence east of the pond, this material can be returned to the pond. Previously identified para-grass in the same area appears to be significantly reduced. The redirection of drainage so as not to pond will have the added advantage of reducing para-grass.

Following these activities, it is estimated that an area of 0.12ha will require revegetation. The number of tube stock plants requiring revegetation will be addressed as part of the same Rehabilitation Strategy for the Evaporation Pond and the WRRP.

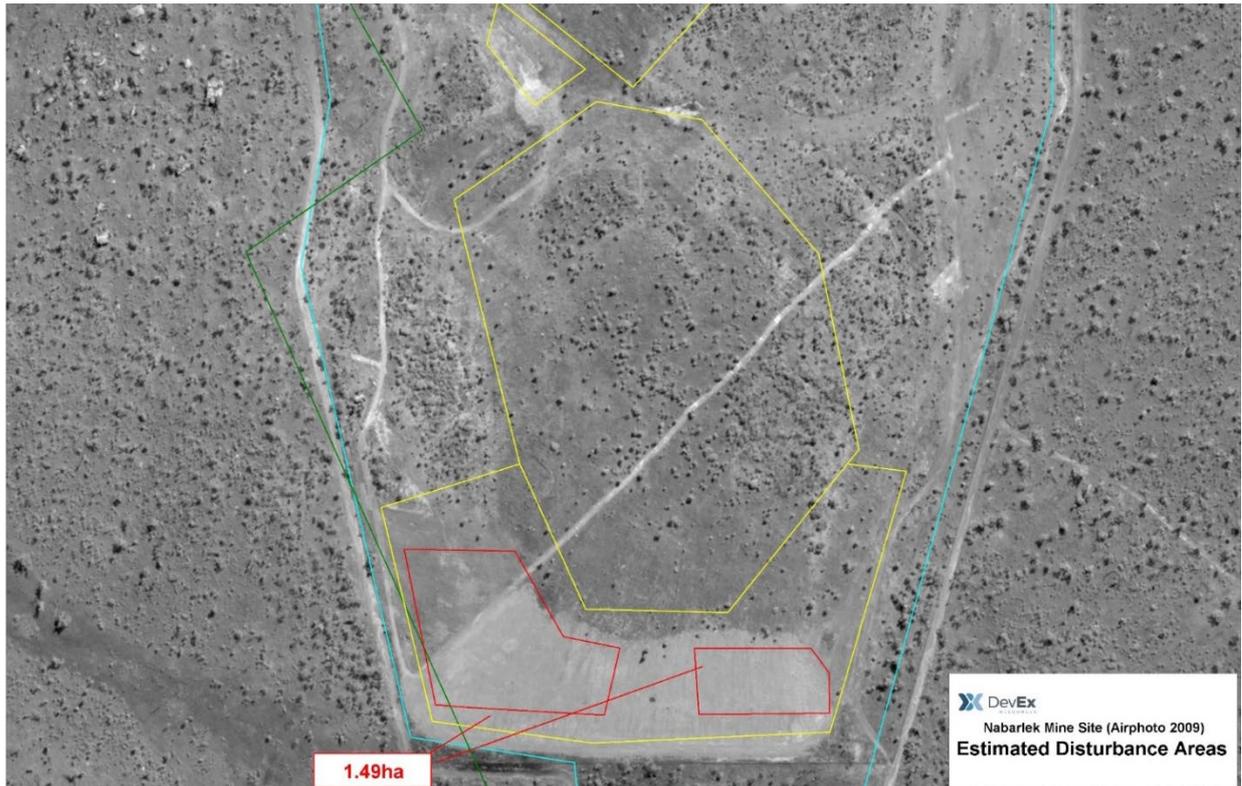
Figure 20: 2009 Airphoto of the Waste Rock Run Off Pond Area showing recent recontouring

Following recontouring of the Waste Rock Runoff Pond [WRRP] in 2008, revegetation on the southern limits show good regrowth when comparing the 2009 Air photo against the recent Geo Image (2016) for the same area (Figure 21 and Figure 22).

As the site requires drainage redirection away from the old pond to the south east (Figure 20), remediated contouring achieving this will require an annual drainage and erosion assessment for a period of three years.

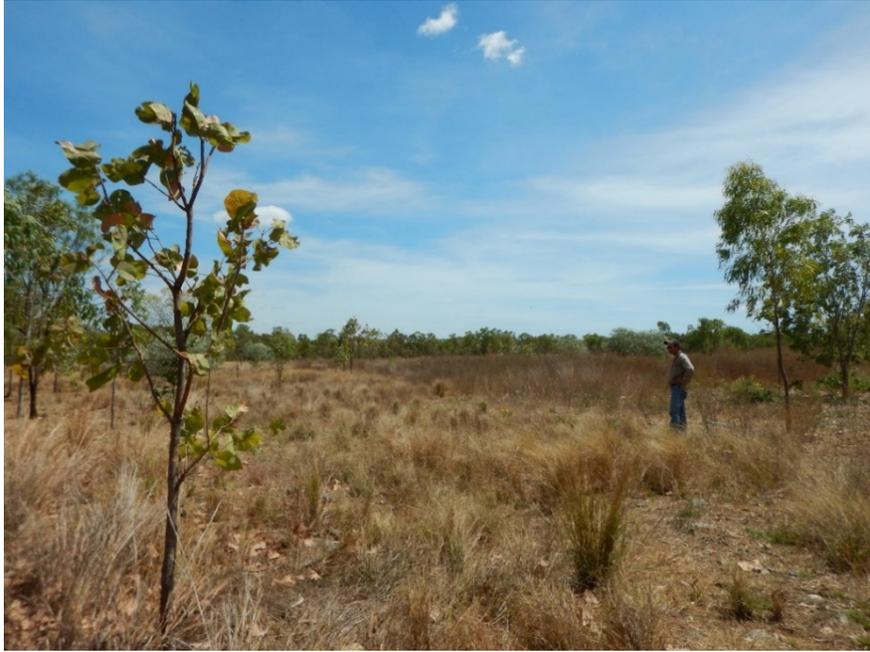
Figure 22: Waste Rock Dump 2017 Photo

In 2017, no significant change in vegetation was observed during the field inspection. Inspection of the soil in the region suggests reasonable moisture holding capacity. It's possible that feral animals may have impacted on previous planting. Additional mixed tube stock planting is recommended to improve density and progress the area towards becoming a woodland suitable for occasional hunting. A walk through of the area in May 2018 indicated that weeds were not in high densities and we now intermixed with native grasses in the region. A May 2018 cool burn of this area was carried out to ensure weeds did not take hold.

As shown in Figure 21 and Figure 22 approximately 1.49ha requires renewed revegetation with tube stock planting once feral animals and weeds are brought under control.
